METALS HANDBOOK

VOL. 9
FRACTOGRAPHY AND ATLAS OF FRACTOGRAPHY

8th EDITION

Fractography and Atlas of Fractographs

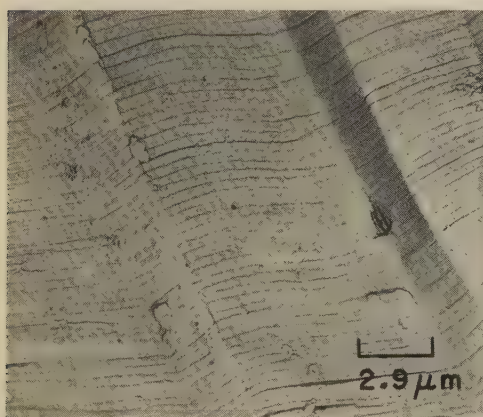
4511

TEM replica of an area in 4509 near (but not at) a fatigue-crack nucleus. In this area, regular, well-developed fatigue striations show curvature, as well as sharp angles at twin boundaries.

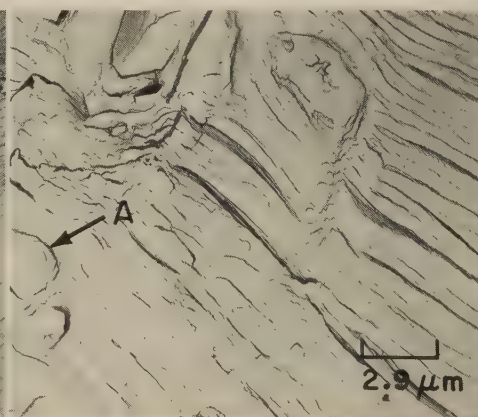
TEM replica of an area in the fatigue zone of the fracture surface in 4509, but an area well away from any fatigue-crack nuclei. The shape of the feature at A suggests an incipient dimple.

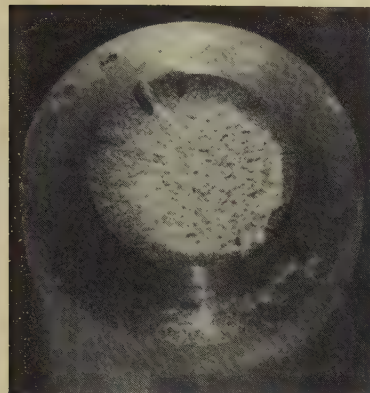
4514, 4515, 4516

Fractograph 4514 (left) shows the surface of a low-cycle fatigue fracture in a notched specimen (notch same as that in 4510) of alloy 718 solution treated and aged to a tensile strength of 1393 MPa (202 ksi). The specimen was loaded at 593 C (1100 F) to a tensile stress cycled from 117 to 586 MPa (17 to 85 ksi) at 500 cycles per minute. Fracture occurred after 7500 cycles. Fractograph 4515 (center) is a TEM replica of an area at one of many fatigue-crack nuclei around the root of the notch in 4514, showing a faceted, angular surface with very fine fatigue striations. The surface characteristics here have perhaps been affected by oxidation. Fractograph 4516 (right) is a TEM replica of an area near (but not at) another fatigue-crack nucleus in 4514. Some lines (as at A) are present at an angle with the fatigue striations (as at B); these lines are probably slip lines rather than more fatigue striations, because fatigue striations do not cross each other. Some striations appear to contain fissures. See also 4517 and 4518.

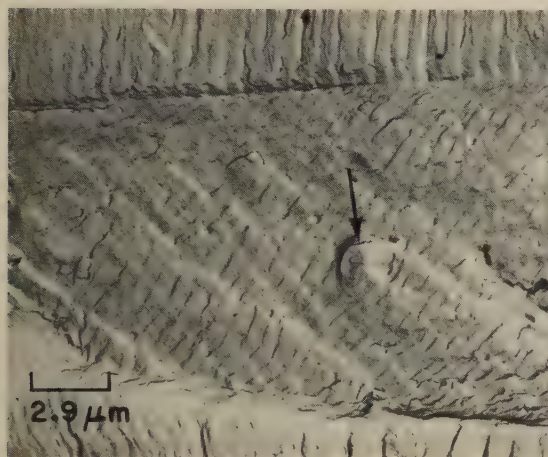
4517 TEM replica of an area of the fracture surface in 4514 well away from any fatigue-crack nucleus. Presence of fatigue patches shows that crack fronts propagated on different levels. Incipient dimple is evident (arrow).

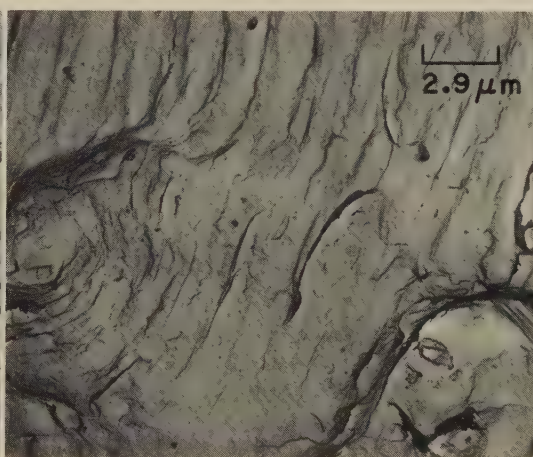
4518 TEM replica of an area in 4514 at the transition between the zone of fatigue and the zone of final, fast fracture. Note that the fatigue striations here are curved, instead of fairly straight as in the area shown in 4517.

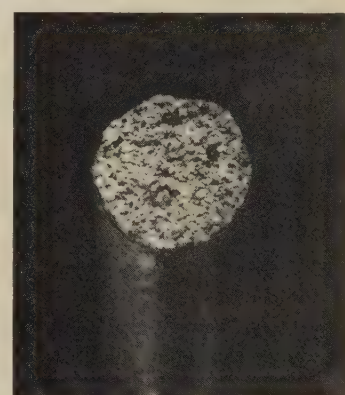
4519 A tension-overload fracture in an unnotched specimen of Waspaloy that was solution treated, aged to a tensile strength of 1230.7 MPa (178.5 ksi), and tested at room temperature. See 4520 to 4522, below.

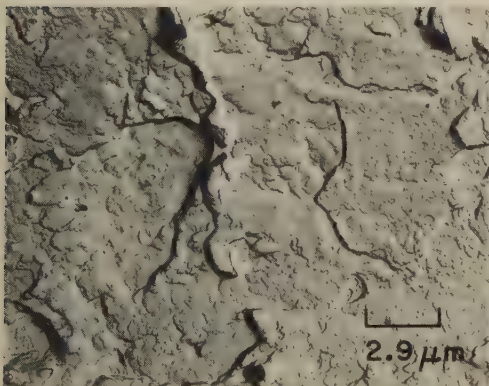
4520 TEM replica of an area at the edge of the fracture surface of the specimen of Waspaloy in fractograph 4519 (above, at right), showing several flat shear dimples and scattered steps or ledges.

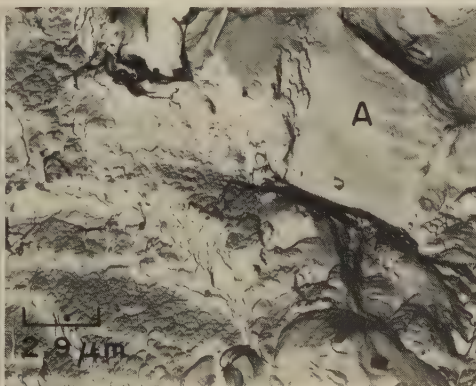
4521 TEM replica of another area of the fracture in 4519, near the area in 4520, showing some very smooth, stretched facets (A), a few normal-size dimples, and regions of extremely fine dimples.

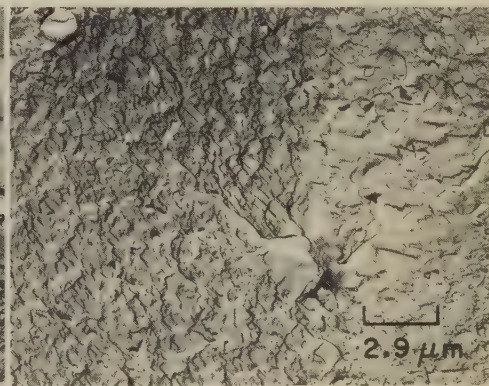
4522 TEM replica of area at center of fracture surface in 4519, showing a portion of a relatively flat facet covered with very fine dimples. Almost no normal-size dimples were visible near this area.

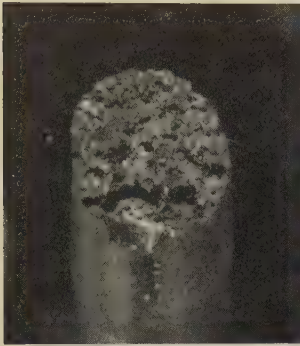
Light fractograph $3\frac{1}{2}\times$
4523 Jagged fracture in an unnotched specimen of Waspaloy that was solution treated, aged to a tensile strength of 1230.7 MPa (178.5 ksi), and broken by tension overload at 927 C (1700 F). See fractographs 4524 to 4526.

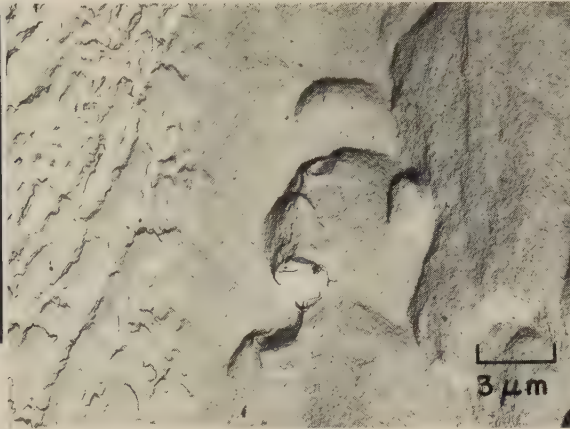
TEM fractograph (p-c replica) $3300\times$
4524 TEM replica of an area in the fracture surface in 4523, showing shear dimples in a wide variety of sizes. In spite of the high temperature of the tension test, only a small amount of surface oxidation is apparent.

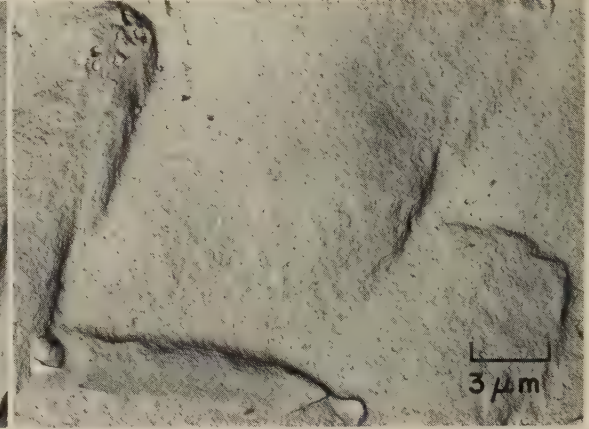
TEM fractograph (p-c replica) $3300\times$
4525 TEM replica of another area in the fracture surface in 4523, showing exceedingly large and very elongated shear dimples. Visible are a few small equiaxed dimples of about the same size as that of the dimples at left in fractograph 4524.

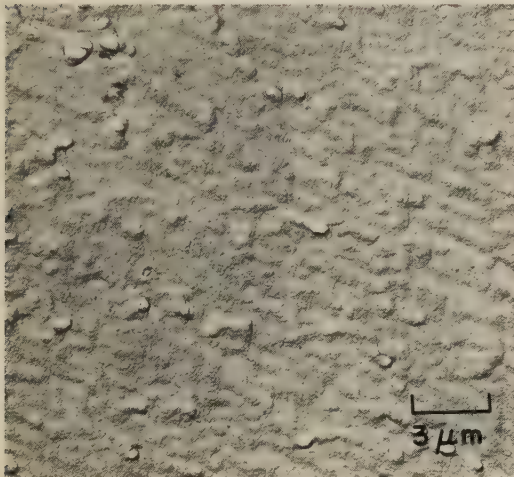
TEM fractograph (p-c replica) $3300\times$
4526 TEM replica of a third area of the fracture surface in 4523, showing a very large flat region containing many small dimples. The surface has a fine graininess that suggests the presence of a high-temperature oxide film.

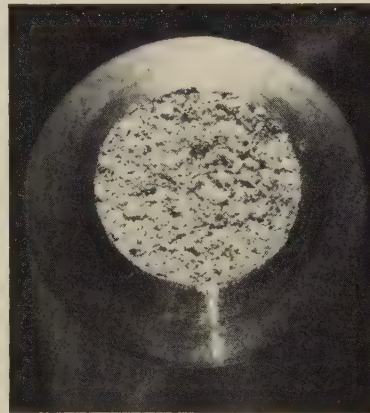
Light fractograph $3\frac{1}{2}\times$
4527 Tension-overload fracture in a notched specimen of Waspaloy (notch same as that described in 4510) that was solution treated, aged to a tensile strength of 1230.7 MPa (178.5 ksi), and broken at room temperature. See also 4528 to 4531.

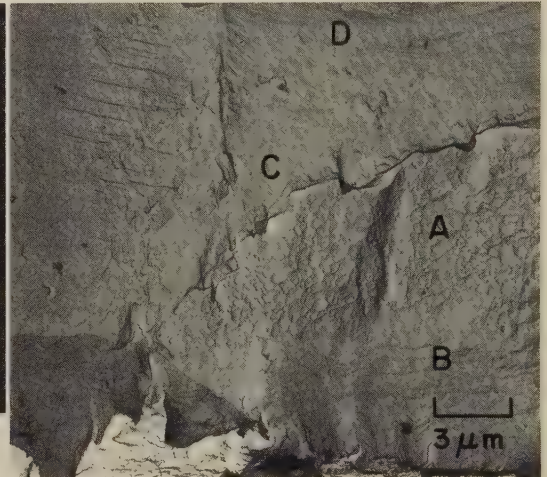
TEM fractograph (p-c replica) $3300\times$
4528 TEM replica of an area at the notch in the fracture surface in 4527, showing extremely flat shear dimples (A), regions of serpentine glide (B), regions of stretching (C), and suggestions of ripples (D).

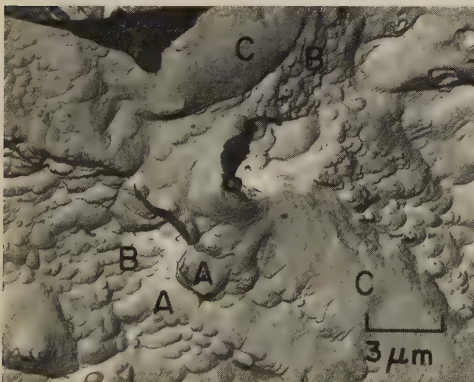
TEM fractograph (p-c replica) $3300\times$
4529 TEM replica of an area near (but not at) the notch in 4527. A few large, elongated dimples (A's) and many small shear dimples (B's) are evident, as well as several regions of stretching (C's).

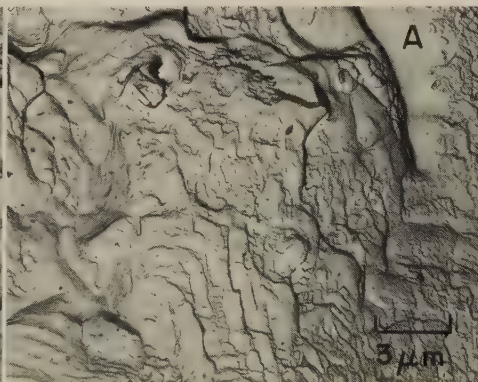
TEM fractograph (p-c replica) $3300\times$
4530 TEM replica of an area near the center of the fracture surface in 4527, showing large facets with fine dimples, a region of stretching (A), and serpentine glide (at lower left). See 4531.

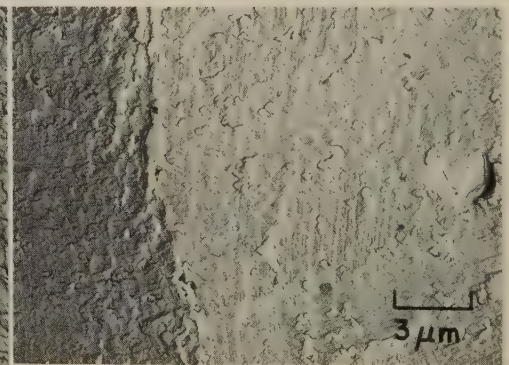
TEM fractograph (p-c replica) $3300\times$
4531 TEM replica of another area near the center of the fracture surface in 4527, showing two large, flat facets. The facet at left contains fine, shallow dimples; the facet at right shows few dimples but perhaps two of many possible systems of slip.

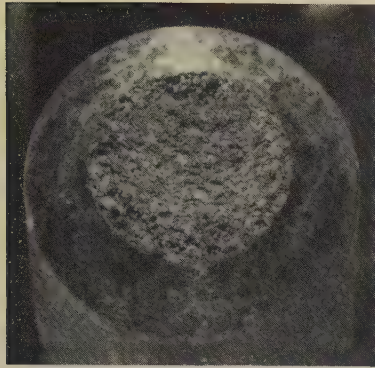
Light fractograph 3½×
4532 Tension-overload fracture in a notched specimen of Waspaloy that was solution treated, aged to a tensile strength of 1230.7 MPa (178.5 ksi), and tested at 927 C (1700 F). A coarsely granular surface. See TEM fractographs 4533 to 4536.

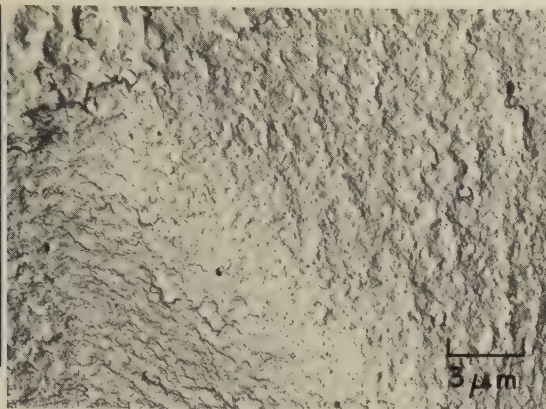
TEM fractograph (p-c replica) 3300×
4533 TEM replica of an area of the fracture surface in 4532, at the notch, which is the same as that in 4510. The topography here resembles that resulting from grain-boundary separation but may have been affected in appearance by the presence of an oxide film.

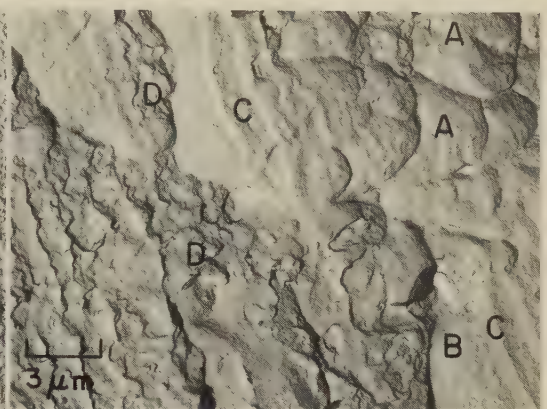
TEM fractograph (p-c replica) 3300×
4534 TEM replica of an area near (but not at) the notch in fractograph 4532. The facets shown here contain large, elongated dimples (at A's), stretched regions (as at B), and some evidence of serpentine glide (at C's). The features at D's do not appear to be dimples.

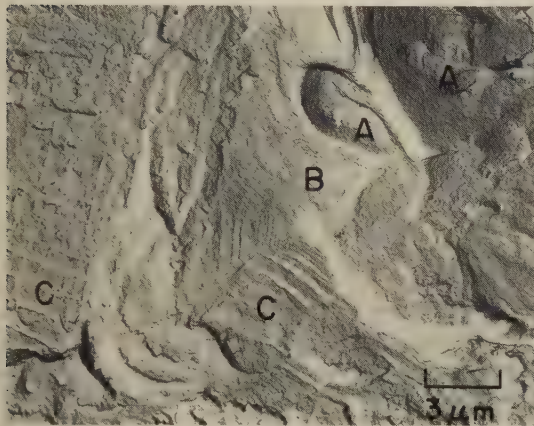
TEM fractograph (p-c replica) 3300×
4535 TEM replica of an area at the center of the fracture surface in 4532, showing dimples (A's) interspersed with regions of stretching (B). Note the unusual array of parallel marks (C's) that resemble fatigue striations; these marks may be glide-plane decohesions or slip, or may be due to microstructure. See 4536.

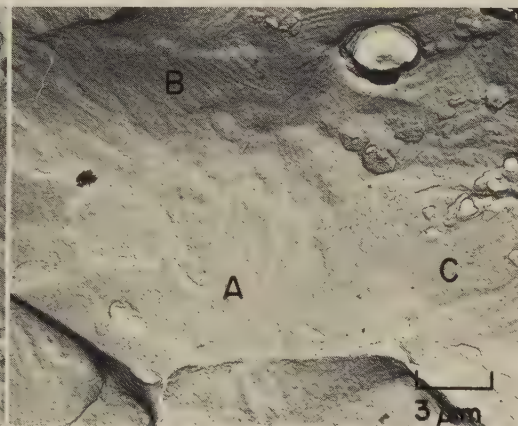
TEM fractograph (p-c replica) 3300×
4536 TEM replica of another area at the center of the fracture surface in 4532. The facets shown here are much larger than those in fractograph 4535. As elsewhere in this fracture, the surface in this area exhibits stretched regions (A) and serpentine glide (B), with occasional suggestions of ripples (C).

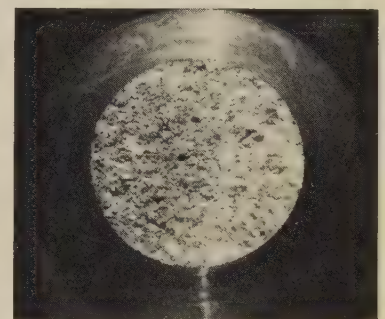
Light fractograph 3¾×
4537 Fatigue fracture in a notched specimen of Waspaloy (notch same as in 4510) solution treated, aged to a tensile strength of 1230.7 MPa (178.5 ksi), loaded at room temperature to a stress cycled from 124 to 621 MPa (18 to 90 ksi) at 500 cycles per minute. Fracture occurred after 16,600 cycles. See 4538 to 4546 (below, and on the next page).

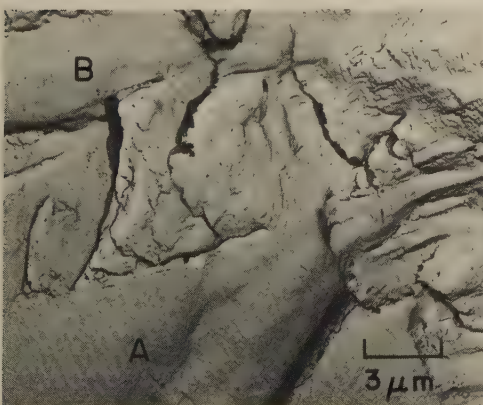
TEM fractograph (p-c replica) 3300×
4538 TEM replica of an area at a fatigue-crack nucleus in the root of the notch in the fracture surface shown in 4537 (at right, above). This area exhibits exceedingly fine fatigue striations (at A and B).

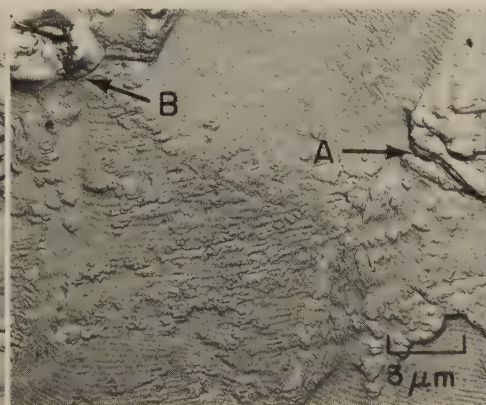
TEM fractograph (p-c replica) 3300×
4539 TEM replica of an area in 4537 adjacent to that shown in 4538. Fatigue striations are slightly more widely spaced here than in 4538. Possible inclusions or large precipitates are visible at A and B.

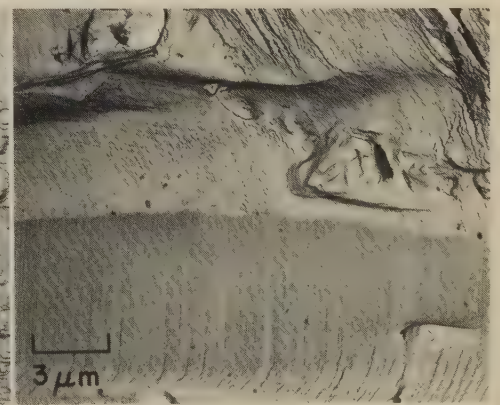
TEM fractograph (p-c replica) 3300×
4540 TEM replica of another area at a fatigue-crack nucleus in 4537, showing very fine fatigue striations at different levels. See also fractographs 4541 to 4546, on the following page.

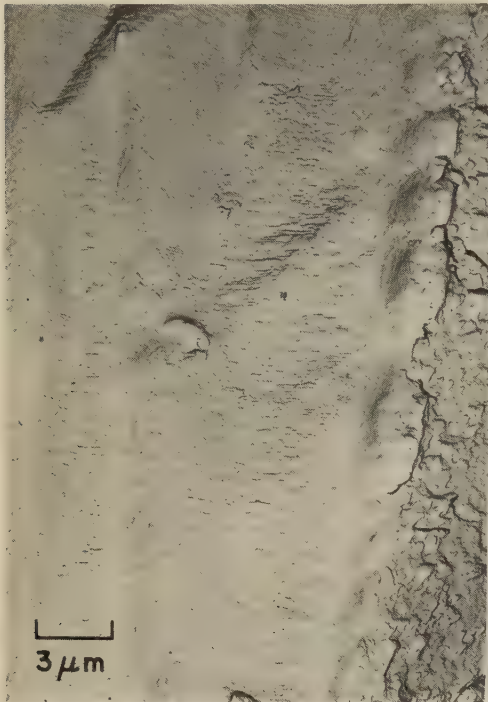
TEM fractograph (p-c replica) 3300×
4541 TEM replica of a fourth area at a fatigue-crack nucleus in 4537 (preceding page), showing fatigue striations at different levels of crack propagation. The features at right are not dimples.

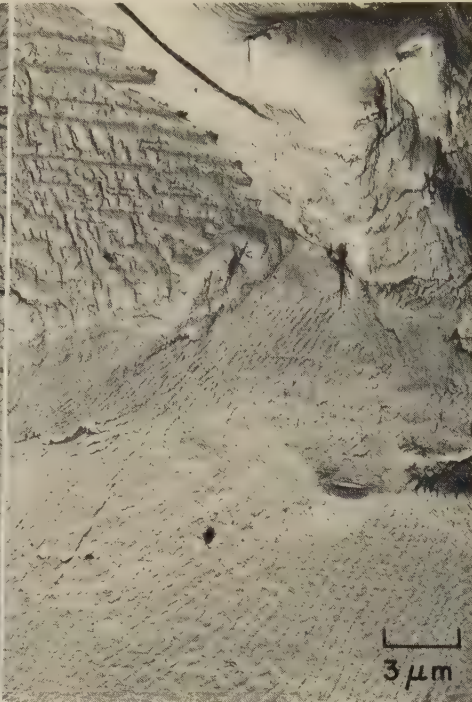
TEM fractograph (p-c replica) 3300×
4542 TEM replica of an area near (but not at) a crack nucleus in 4537. Note the marks at upper left, which certainly are not fatigue striations but perhaps are related to crystal structure.

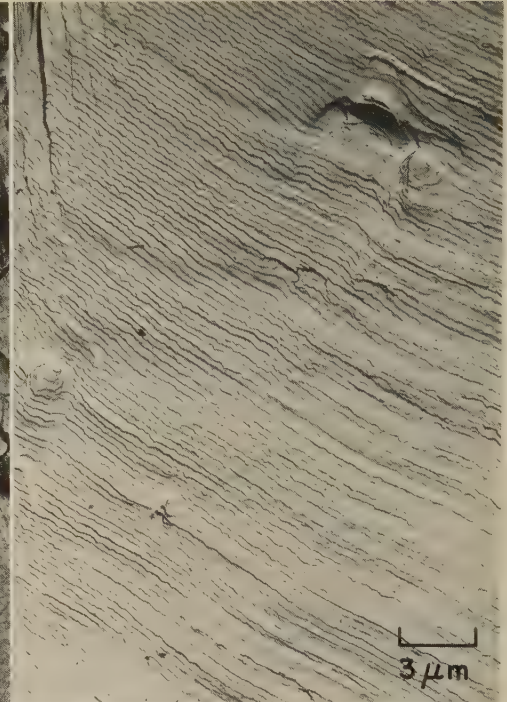
TEM fractograph (p-c replica) 3300×
4543 TEM replica of another area near (but not at) a crack nucleus in 4537. The fatigue striations here are very uniform. Note the additional marks at top left, which may be cleavage steps.

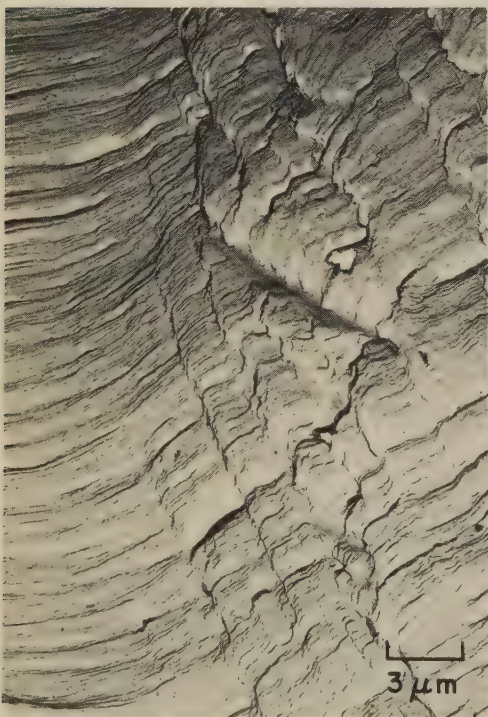
TEM fractograph (p-c replica) 3300×
4544 A third area near (but not at) a crack nucleus in 4537, showing fatigue striations resulting from propagation of several crack fronts on different levels. Irregularity of striation pattern at right may have been caused by microstructure.

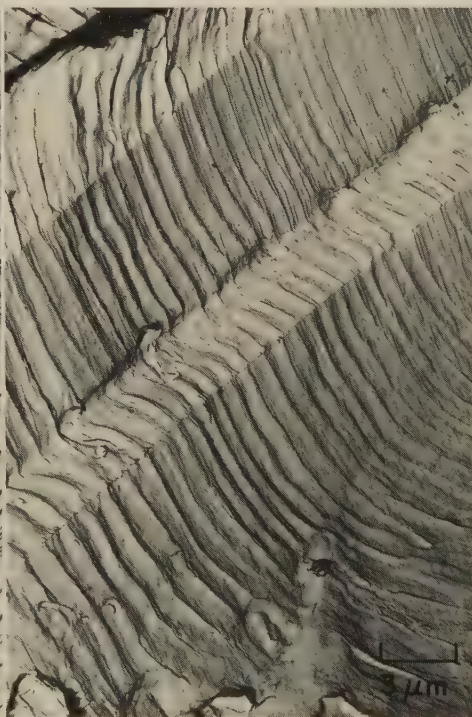
TEM fractograph (p-c replica) 3300×
4545 TEM replica of an area of the fracture surface in 4537 well away from any fatigue-crack nucleus. Fatigue striations along twin boundaries are evident, and the spacing between striations has increased with crack penetration.

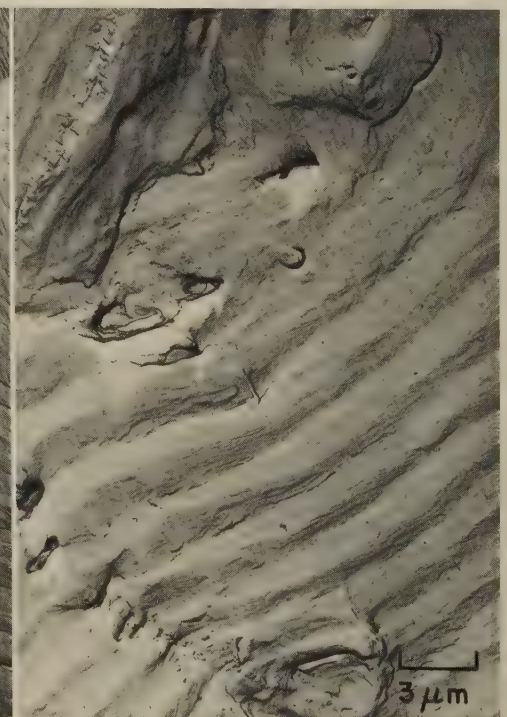
TEM fractograph (p-c replica) 3300×
4546 TEM replica of an area at the transition from fatigue fracture to final, fast fracture in 4537. Note that the striation spacing has increased markedly as the cross section has decreased and the effective stress has increased.

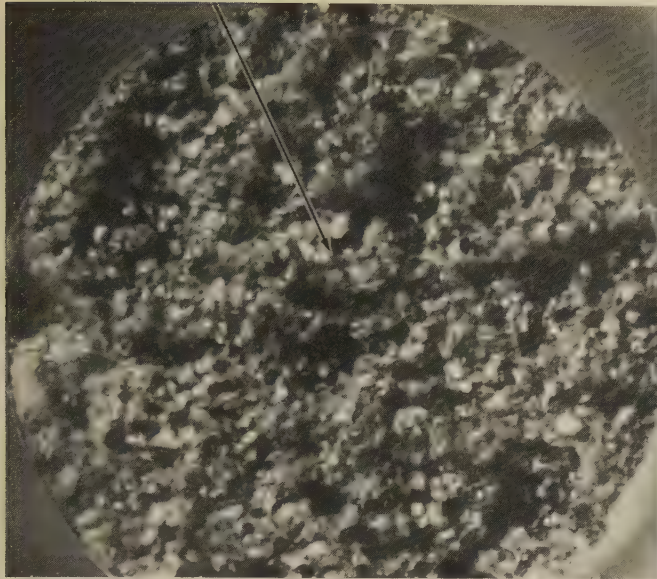
4547, 4548

Fractograph 4547 (left) shows the surface of a "rock candy" type of fracture in an unnotched specimen of nickel-base heat-resisting alloy René 41 that had been solution treated at 1177 C (2150 F) and aged at 899 C (1650 F) to a tensile strength of 1076 MPa (156 ksi). The specimen was broken by tension overload at room temperature. Fractograph 4548 (right) is a TEM view of an area, at arrow, in the center of the fracture in 4547, which appears to be intergranular. This TEM replica reveals flat, elongated dimples, which have formed on what may be large separated-grain facets.

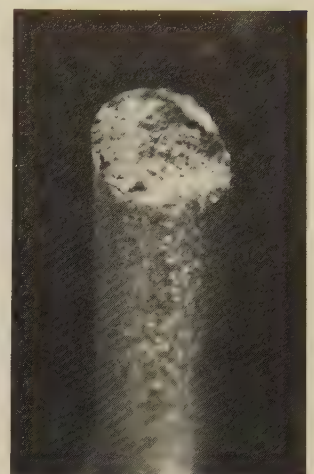
4549

Tension-overload fracture in an unnotched specimen of solution treated cobalt-base alloy L-605; the tensile strength was 951 MPa (138 ksi). A jagged shear fracture. See also 4550 to 4552, below, for TEM views of three areas of this room-temperature fracture.

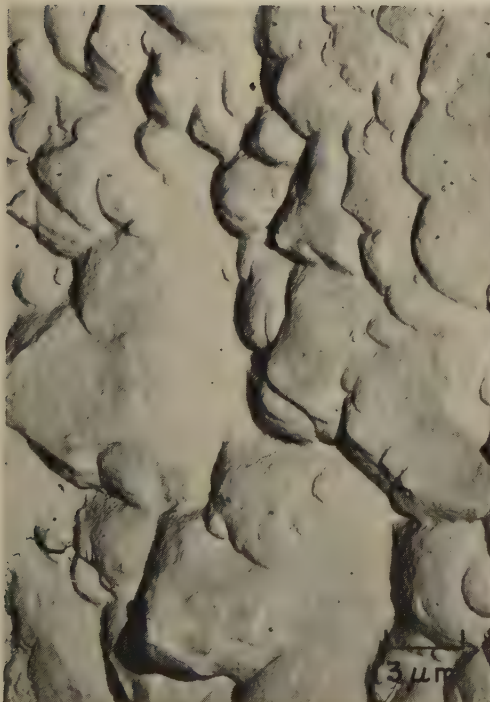
4550 TEM replica of an area at the edge of the fracture surface in 4549 (above, at right), showing shear dimples and several regions of stretching.

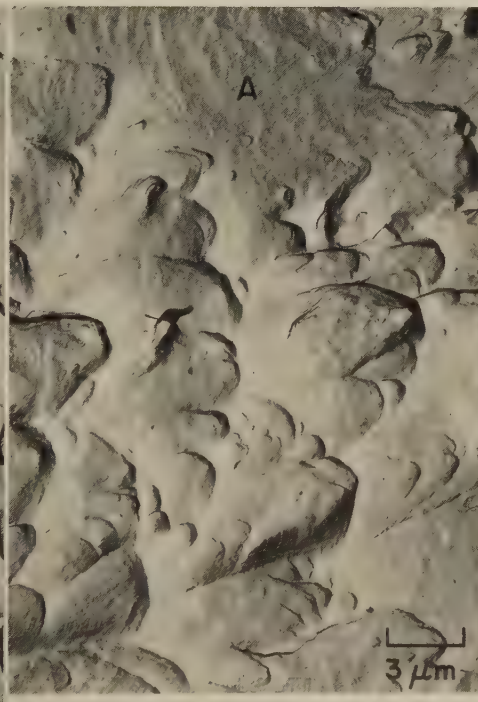
4551 TEM replica of an area near (but not at) the edge of the fracture surface in 4549. Like 4550, this view shows shear dimples and stretched regions; also visible here are suggestions of ripples (at A).

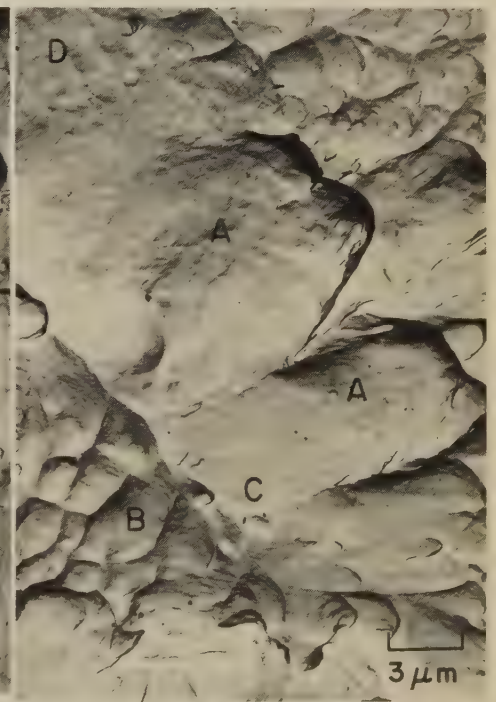
4552 TEM replica of area at center of fracture in 4549. Large, elongated dimples (A's); essentially equiaxed dimples (B); stretched regions (C); ripples (D).

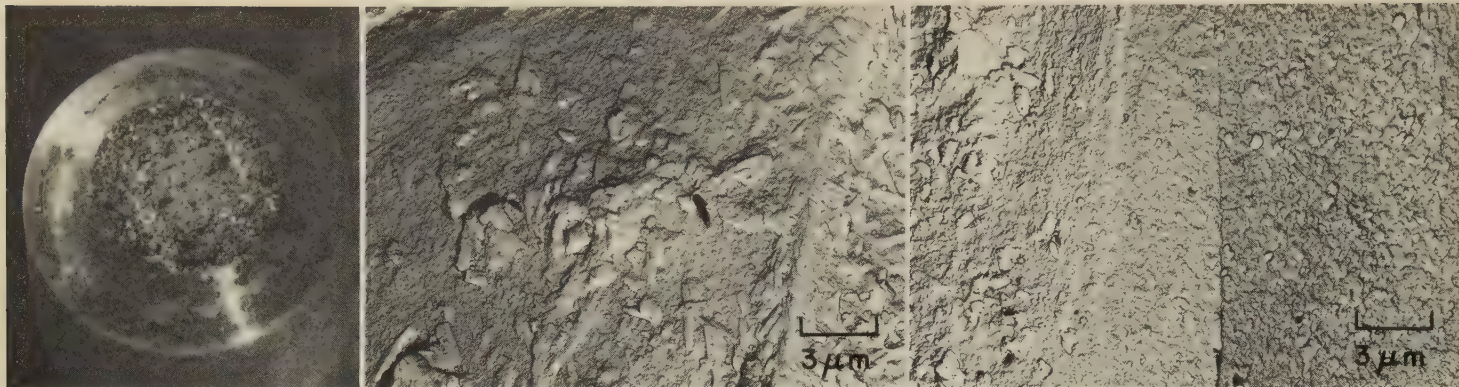
Light fractograph 350× TEM fractograph (p-c replica) 3300× TEM fractograph (p-c replica) 3300×
4553, 4554, 4555 Fractograph 4553 (left) shows the surface of a tension-overload fracture in a notched specimen of cobalt-base alloy L-605 that was solution treated 15 min at 1332 C (2250 F) and air cooled. Unnotched tensile strength was 951 MPa (138 ksi). The notch had a 60° angle, 0.30-in. diam, and 0.008-in. root radius. The specimen was broken at 927 C (1700 F), which produced a coarse, jagged, granular fracture. Notched hot tensile strength was 531 MPa (77 ksi). Fractographs 4554 (center) and 4555 (right) are TEM replicas of two areas near the notch in 4553, each showing portions of two separated-grain facets. Well-developed oxide crystals are visible on the facets in 4554. Oxide particles are also present on the left facet in 4555, but there are fewer of them than in 4554 and they are not as well developed. See also fractographs 4556 and 4557 (below).

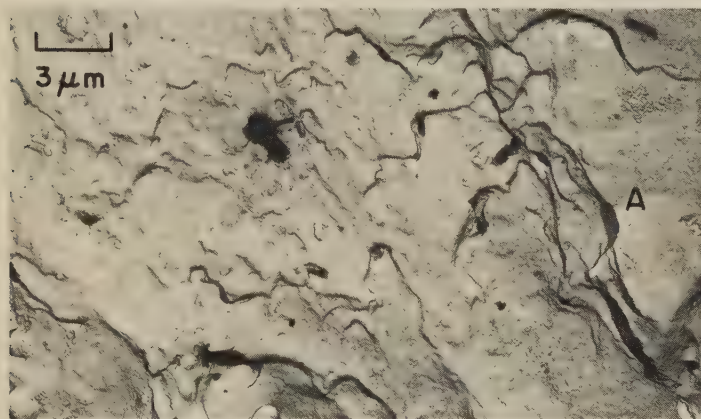
TEM fractograph (p-c replica) 3300×
4556 TEM replica of an area at the center of the fracture surface in 4553. This area appears to have formed by transgranular fracture and contains rather flat facets; some portions, as at A, are smooth enough to suggest stretching.

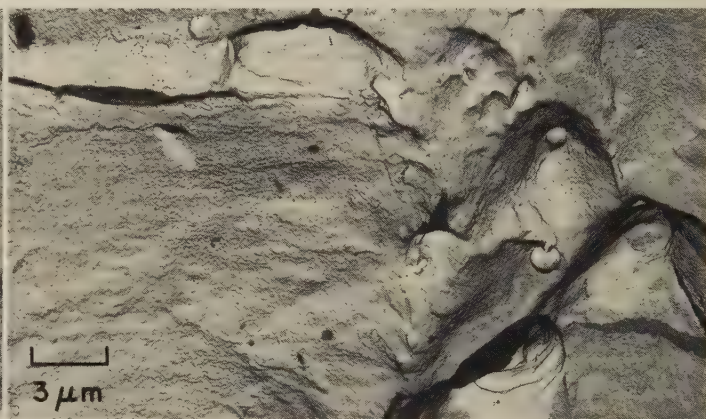
TEM fractograph (p-c replica) 3300×
4557 TEM replica of another area at the center of the fracture in 4553. Both transgranular fracture and intergranular fracture appear to have occurred here; a separated-grain facet is visible at left, and directional dimples at right.

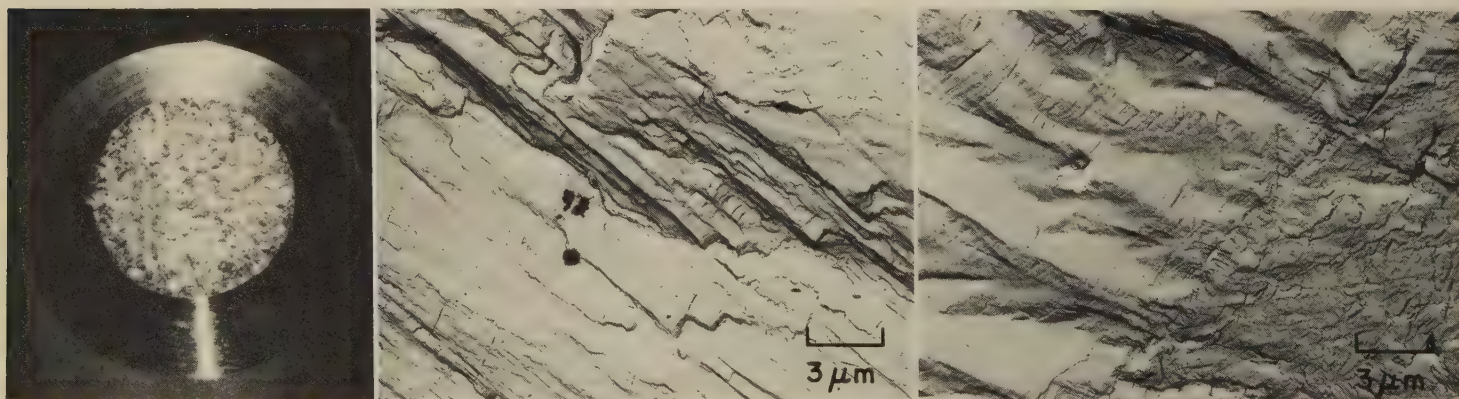
Light fractograph 312× TEM fractograph (p-c replica) 3300× TEM fractograph (p-c replica) 3300×
4558, 4559, 4560 Fractograph 4558 (left) shows the surface of a high-cycle fatigue fracture in a notched specimen of solution treated cobalt-base alloy L-605 (notch and heat treatment same as in 4553). Tensile strength was 951 MPa (138 ksi). The specimen was loaded to a stress cycled from 97 to 483 MPa (14 to 70 ksi) at 500 cycles per minute and broke after 110,000 cycles. Fractograph 4559 (center) is a TEM replica of a region at the fatigue-crack nucleus of the fracture in 4558. Few recognizable fatigue striations are visible here. Instead, there are many angular facets. The faint transverse marks in the lower left quadrant of this view are of unknown origin. Fractograph 4560 (right) is a TEM replica of an area near (but not at) the fatigue-crack nucleus of the fracture in 4558. The fatigue patches at left show an influence of microstructure. The features at lower right are similar to those at upper right in 4559. See also fractographs 4561 to 4566, on the opposite page.

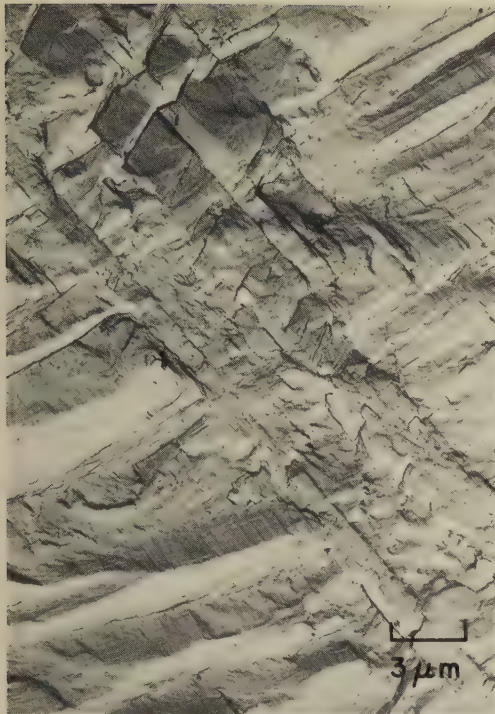
TEM fractograph (p-c replica) 3300×
4561 TEM replica of a second area near (but not at) the fatigue-crack nucleus in 4558 (facing page). Diagonal band (upper left to lower right) suggests a line of inclusions; otherwise, this area bears some resemblance to the area in 4560.

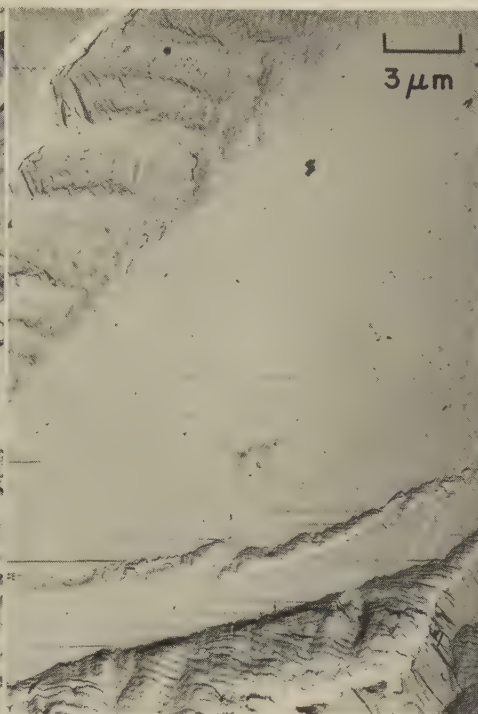
TEM fractograph (p-c replica) 3300×
4562 TEM replica of a third area near (but not at) the nucleus in 4558. Differences in crystal orientation have resulted in some regions being smooth with light striations, others rough with heavy striations. The sharp lines may be steps.

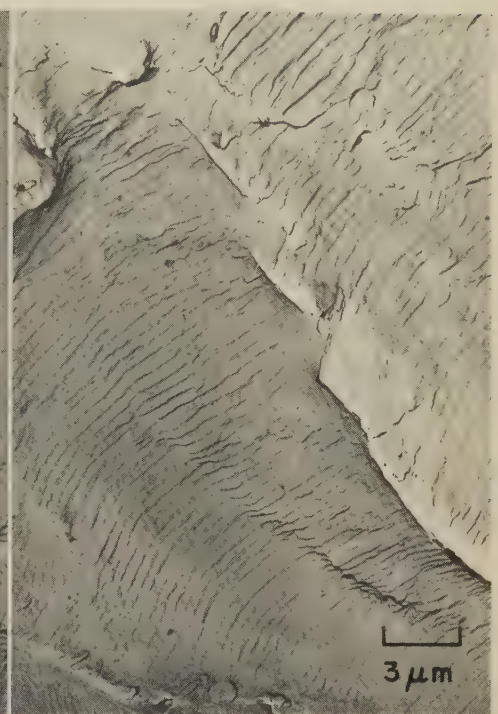
TEM fractograph (p-c replica) 3300×
4563 TEM replica of an area well away from the fatigue-crack nucleus of the fracture in 4558. Diagonal marks (upper left to lower right) are steps separating two adjacent fatigue patches showing regular, well-resolved fatigue striations.

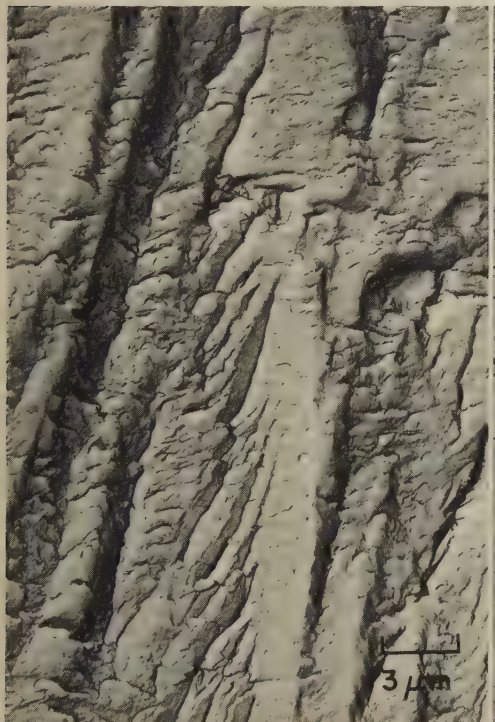
TEM fractograph (p-c replica) 3300×
4564 TEM replica of another area well away from the fatigue-crack nucleus in 4558, showing a particularly strong influence of microstructure on surface pattern, which is quite irregular.

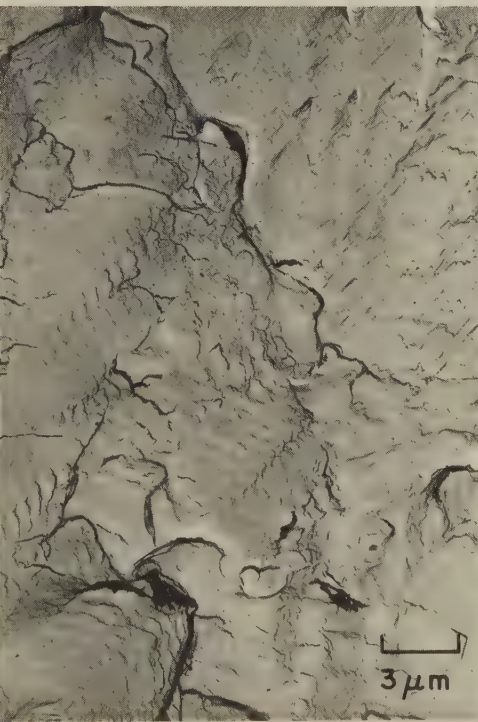
TEM fractograph (p-c replica) 3300×
4565 TEM replica of an area near the transition between fatigue fracture and final, fast fracture in 4558, showing "tire tracks" (at left) and features that suggest scraping (at right).

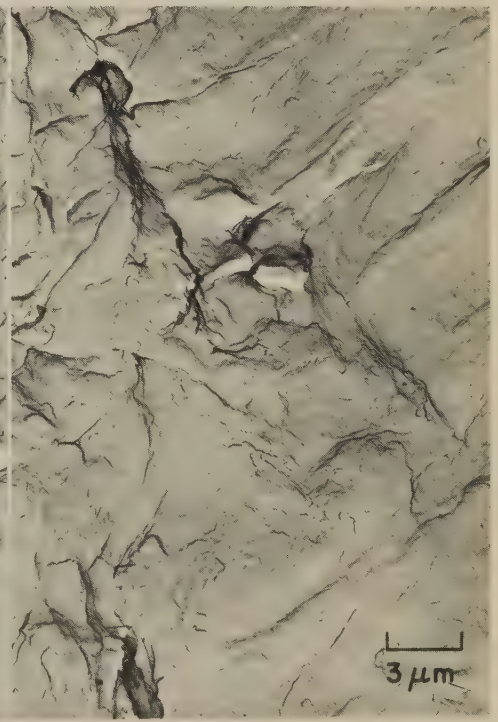
TEM fractograph (p-c replica) 3300×
4566 TEM replica of another area near the transition between fatigue and fast fracture in 4558. Striation spacing is extremely wide, indicating that this area is very close to the fast-fracture zone.

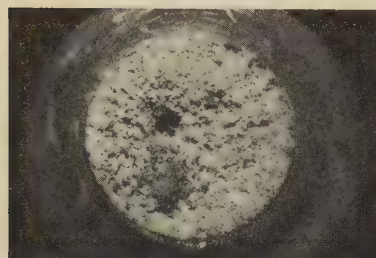
Light fractograph 3.6×
4567 Tension-overload fracture in a notched specimen of U-700 alloy solution treated at 1079 C (1975 F), and aged 24 hr at 843 C (1550 F) and 16 hr at 760 C (1400 F), to tensile strength of 1462 MPa (212 ksi), then broken at room temperature. Notch had a 60° angle, 0.30-in. diam, 0.008-in. root radius. Notched tensile strength, 1731 MPa (251 ksi). See 4568-4571.

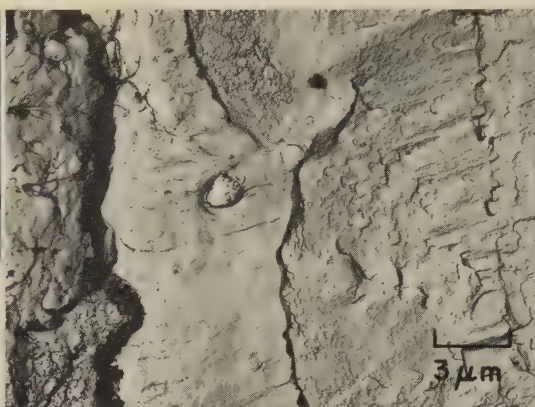
TEM fractograph (p-c replica) 3300×
4568 TEM replica that was taken at the left edge of the tension-overload fracture shown in 4567 (left). The surface in this area is characterized mainly by flat and shallow dimples. Steplike marks are evident between some facets.

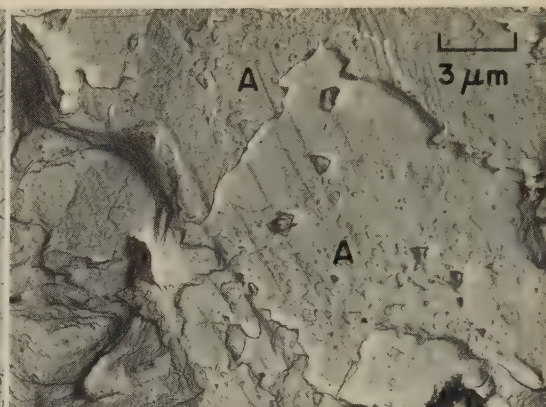
TEM fractograph (p-c replica) 3300×
4569 A TEM replica taken near (but not at) the notch of the fracture in 4567. Facets here are very flat, and there is a sparse sprinkling of tiny depressions (at A's). Steps between facets are evident here, as in fractograph 4568.

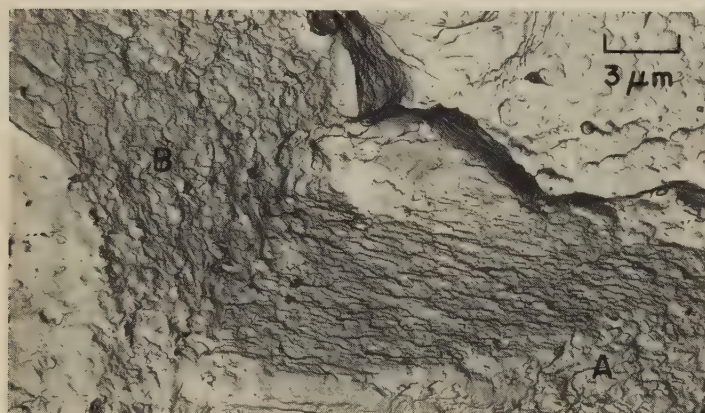
TEM fractograph (p-c replica) 3300×
4570 A TEM replica of an area at the center of the fracture surface shown in 4567. Intergranular rupture, with fine shear dimples visible on the separated-grain facets at A and B.

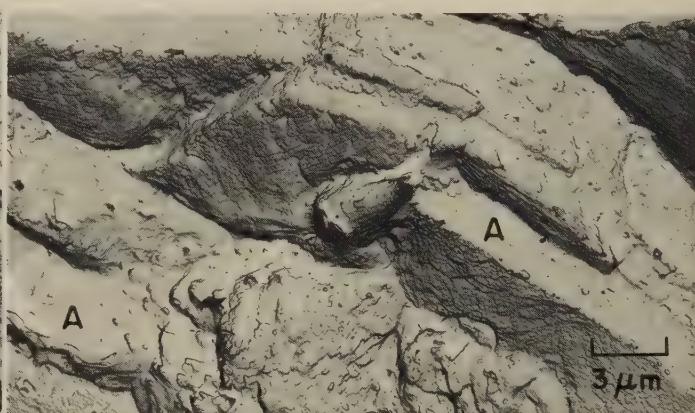
TEM fractograph (p-c replica) 3300×
4571 TEM replica of another area at center of fracture surface in 4567. This area, like that in 4570, displays separated-grain facets, but with intervening stretched regions (A's).

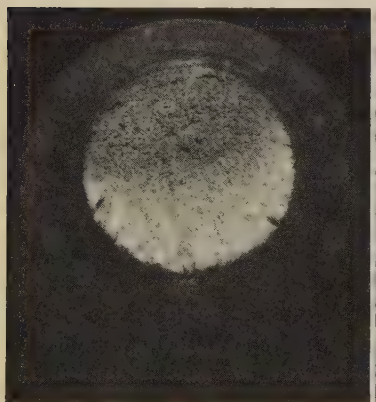
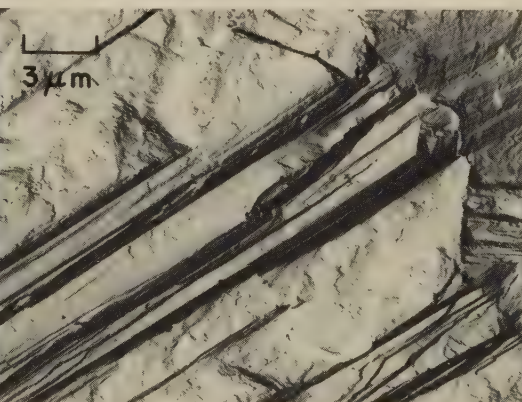
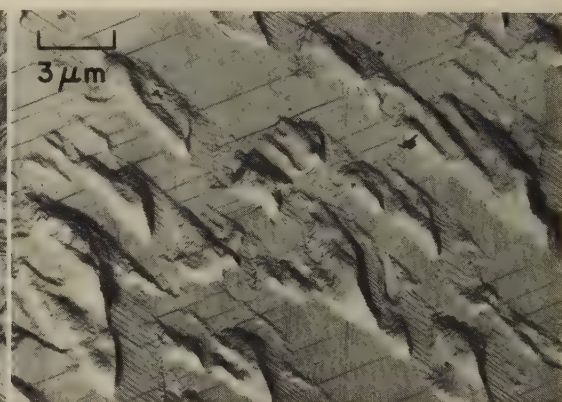
Light fractograph 3.6×
4572, 4573, 4574

Fractograph 4572 (left) shows the surface of a fatigue fracture in a notched specimen of U-700 alloy (notch and heat treatment same as in 4567); tensile strength, 1462 MPa (212 ksi). Tested at room temperature at 500 cycles per minute, at stress of 1379 MPa (200 ksi) max and 138 MPa (20 ksi) min; broke at 12,600 cycles. The fracture had multiple origins and propagated along a crescent-shaped front (light area at bottom and right). Fractograph 4573 (center) is a TEM replica taken at one of the fatigue-crack origins in 4572. The angular, faceted topography here reflects strongly the influence of crystallographic orientation. The straight, fine lines visible in bands are of unknown source. Fine fatigue striations exist in the regions between the bands. Fractograph 4574 (right) is a TEM replica of another area in the nucleus region of the fracture surface in 4572. Angular facets show fatigue striations. The cause of the flat regions is not understood, but repeated replications showed the flatness to be real. The fine parallel lines are believed to represent two systems of slip (vertical, and at 30° to horizontal). See also fractographs 4575 to 4580 (opposite page), for TEM replicas of other areas of this fracture surface.

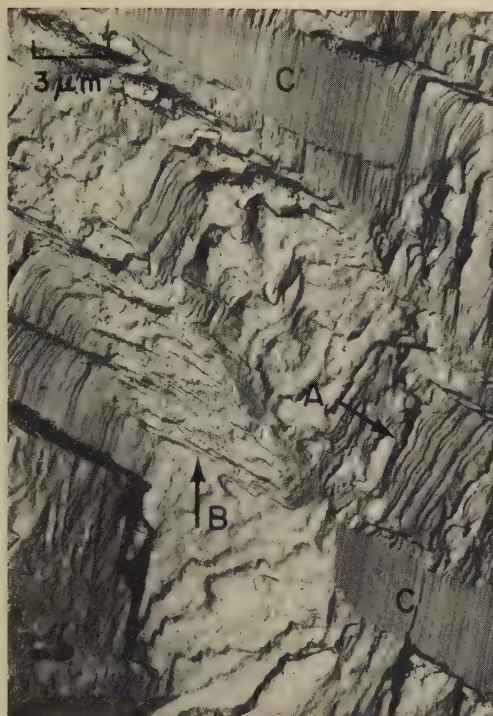
TEM fractograph (p-c replica) 3300×

4575 TEM replica of a third area in nucleus region of fracture in 4572. Central area shows what appear to be irregular fatigue striations (at A and B). Fine marks on facets at C's are not artifacts or striations but may have resulted from abrasion by the mating fracture surface.

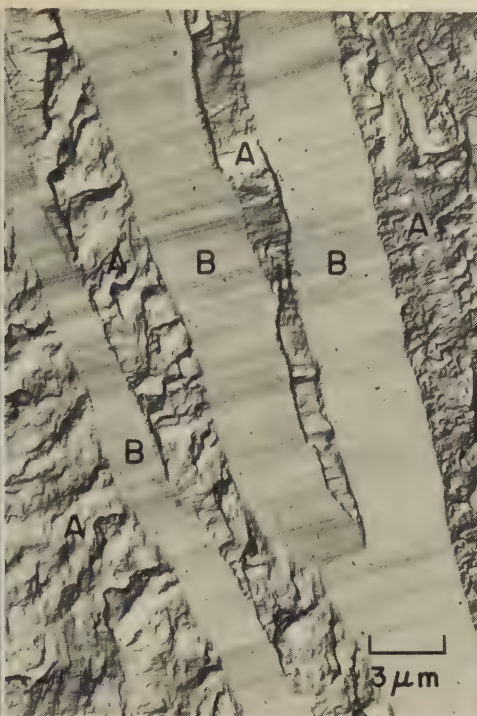
TEM fractograph (p-c replica) 3300×

4576 A TEM replica taken near (but not at) nucleus in 4572. Note extreme difference in appearance between areas A and areas B. Areas A show what may be very irregular striations. Features in areas B are not artifacts; they may indicate slip, or abrasion by the mating fracture surface.

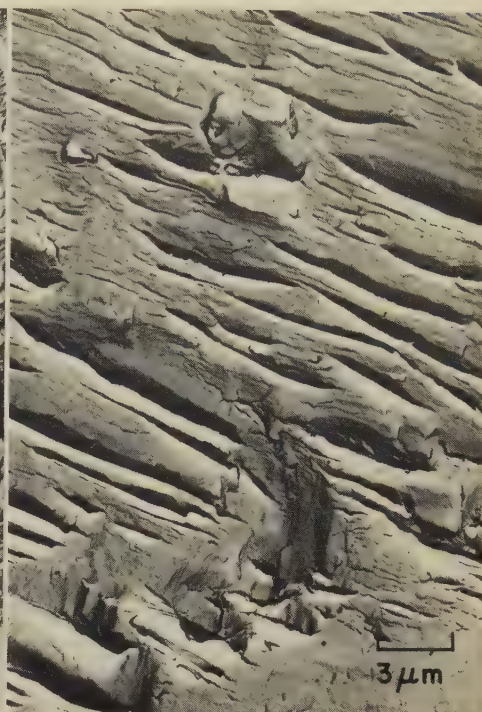
TEM fractograph (p-c replica) 3300×

4577 A TEM replica of an area well away from the fatigue-crack nucleus in 4572. Many fatigue striations here are very deep and distinct, suggesting the generation of secondary cracks; the relatively short length of these deep grooves may be due to microstructural influence.

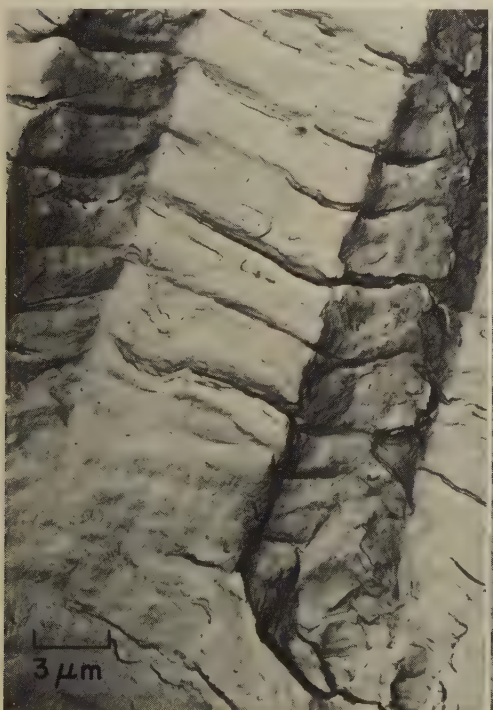
TEM fractograph (p-c replica) 3300×

4578 A TEM replica of another area well away from the fatigue-crack nucleus of the fracture in 4572. Unlike those in 4577, fatigue striations here are quite regular; they are also much more widely spaced, indicating appreciable crack penetration.

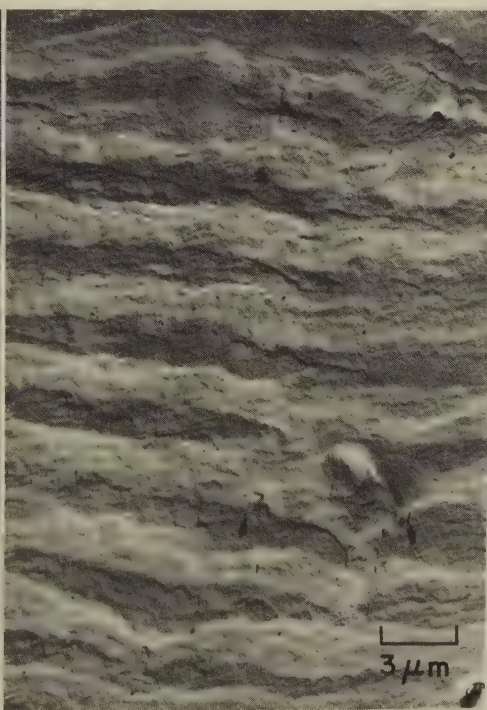
TEM fractograph (p-c replica) 3300×

4579 A TEM replica taken near the transition from fatigue to final, fast fracture in 4572. The reduction in remaining cross-sectional area, and the consequent increase in effective stress, has increased the spacing of the striations appreciably.

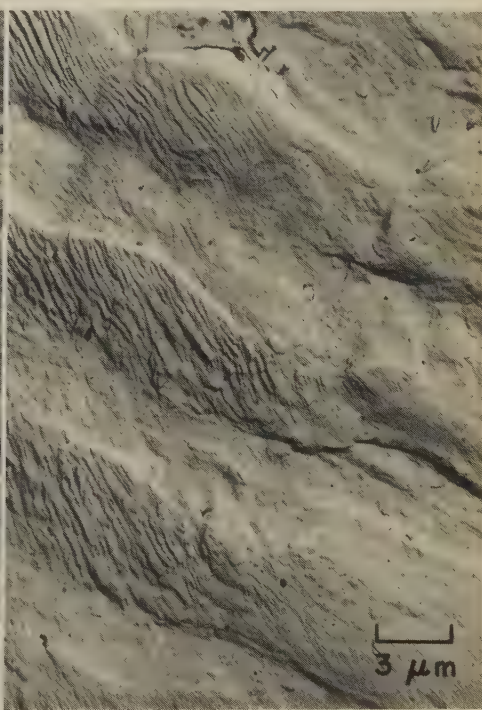
TEM fractograph (p-c replica) 3300×

4580 TEM replica taken at transition from fatigue to final, fast fracture in 4572. Fatigue-striation spacing is very wide. Secondary marks angling across each striation represent slip on a set of favorably oriented crystallographic planes.

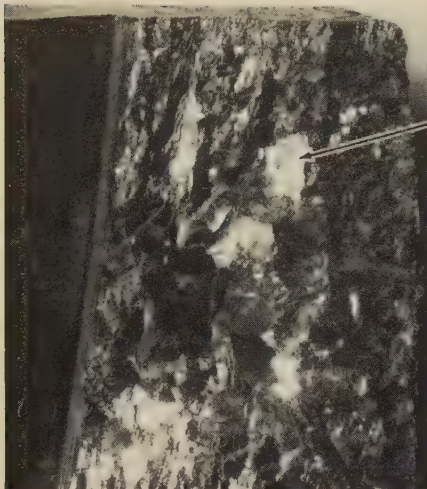
Light fractograph 5½×
4581 Surface of a "rock candy" fracture in a notched as-cast specimen of Alnico alloy broken by impact at room temperature, showing large, shiny facets. The brittle nature of this specimen is reflected in its unnotched tensile strength of only 34 MPa (5 ksi). See also 4582 to 4587.

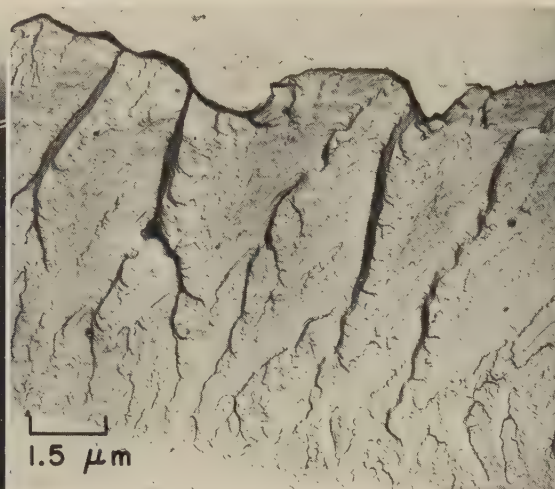
TEM fractograph (p-c replica) 6500×
4582 TEM replica of an area of the facet at the arrow in 4581, showing features resulting from transgranular cleavage. Pronounced cleavage steps in central region indicate that fracture progressed from bottom to top. The margins of this central region are believed to have formed at grain boundaries; the cause of the marked irregularity of the margin at top is not known.
